SHIP SYSTEM Hull Structure	SUBSYSTEM Superstructure	MRC CODE R-	
SYSTEM Hull Deck	EQUIPMENT Superstructure and Fittings	RATES GS-11/12	MH 24.0
MAINTENANCE REQUIREMENT DESCRIPTION 1. Conduct SEMAT assessment procedure for superstructure and fittings (15011).		TOTAL MH 24.0 ELAPSED TIME 24.0	
SAFETY PRECAUTIONS 1. Forces afloat comply with NAVOSH Program Manual for Forces Afloat, OPNAVINST 5100.19 series. 2. Exercise caution in vicinity of electrical equipment, operating machinery and open access openings. 3. Comply with ship's regulations for working above deck; wear safety harness and line.			
TOOLS, PARTS, MATERIALS, TEST EQUIPMENT			
MATERIALS

1. Conduct SEMAT Assessment Procedure for Superstructure and Fittings.

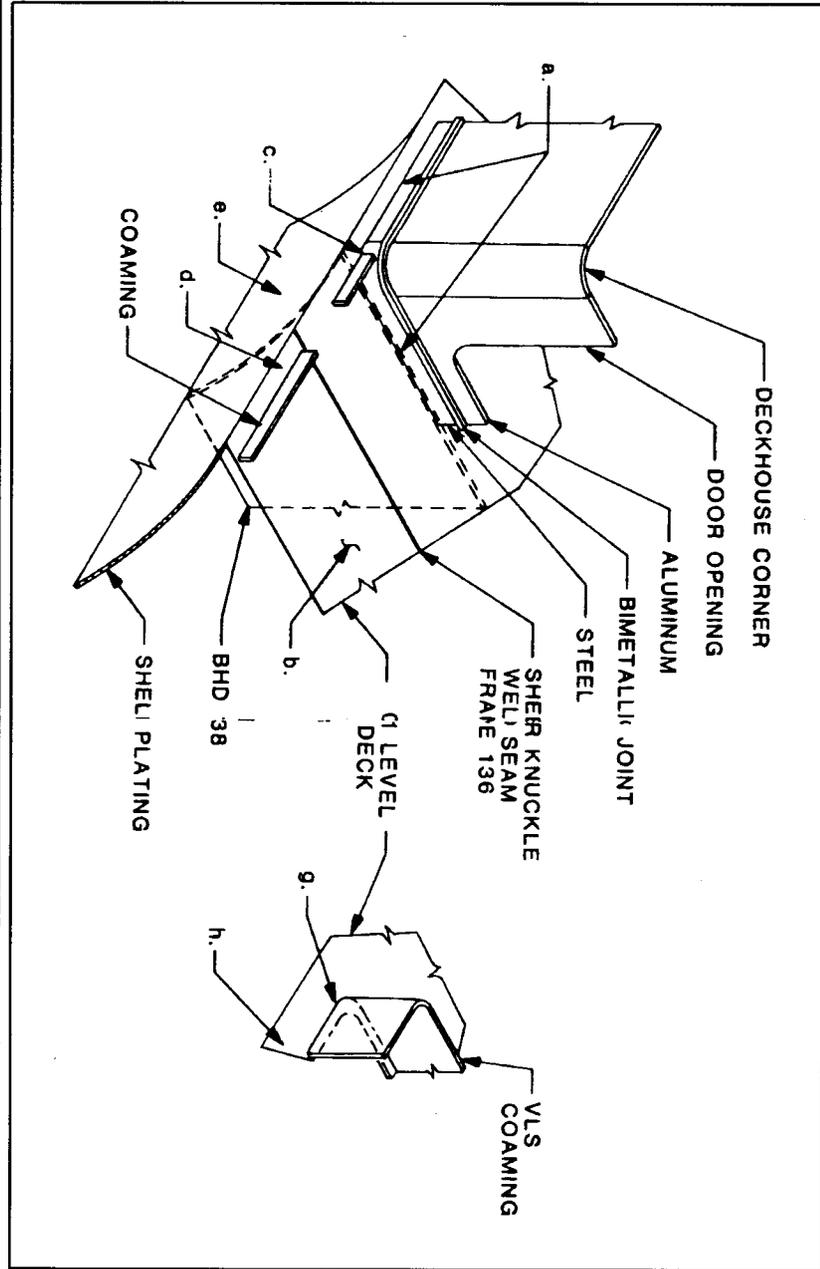
NOTE 7: Figure 1 corresponds to following numbers which designate areas to be assessed. Starboard side shown. Port and starboard side to be assessed.

- h. For FFG-7 Class ships, assess aluminum superstructure for cracks, particularly in the following areas:
 - (1) Deck house sides: port and starboard, main deck to 02 level, frames 196 and 236 in way of knuckles; in particular, 02 level, coaming and superstructure side at 01 level. Look for both horizontal and vertical cracks.
 - (2) 02 deck plating in way of transverse butt welds at frames 201, 220, and 236. Particularly assess welds along entire lengths.
- i. For CG-47 Class ships, assess aluminum superstructure for cracks, particularly in the following areas:

- (2) Assess 01 level deck plate area from deck house at FR 138 to 4 feet forward of deck house, port to starboard. Specifically, check for cracking and check for plate deformation greater than 3/4 inch. Pay special attention to sheer knuckle weld seam along FR 136.

- (6) Assess 01 level deck hatches near FR 138. Applicable hatch numbers are:
 - 01-140-1 and 01-144-1 on all CG-47 Class ships
 - 01-134-1 on the CG-47 and CG-48
 - 01-136-2 on the CG-49 and subsequent ships
- (a) Assess corners of deck openings for cracks; check for crack initiation on both above and below deck surfaces. Check welds, both inside and outside, connecting hatches to deck.
- (7) Assess corners of deck openings for MK-41 missile launcher on CG-52 and subsequent ships. Access to interior of forward VLS is required.
- (8) Assess 4 feet of 01 level deck inboard of deck coaming, forward of deck house. Assess for cracks and deformation of deck plating between longitudinal stiffeners. Report all cracks and any deformations greater than 3/4 inch.
